# DUCATI MULTISTRADA 950 '17-

## M O U N T I N G I N S T R U C T I O N S

REF 20222N

PROTECTOR BASCULANTE PHB19 / PHB19 PROTECTOR SWINGARM

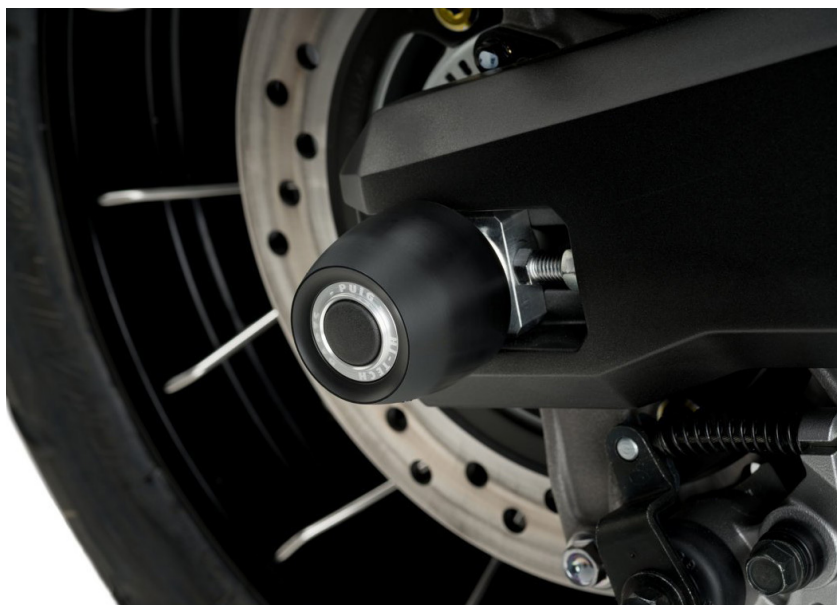
| ID. | PIEZA / PART | QTY. | REF.: |
| 1 | | 1 | PROBAS44-0-0044 |
| 2 | | 1 | PROBAS39-0-0039 |
| 3 | | 1 | VARIFO12-1-0012 |
| 4 | | 2 | TUZBM6000000024 |
| 5 | | 2 | ARANDEPD125-054 |
| 6 | | 2 | TAPAFINALR17-18 |

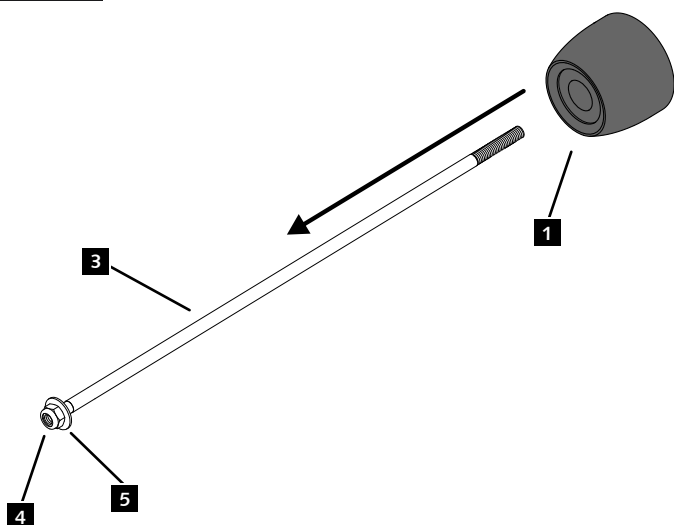
**1**

ASSEMBLY  
MONTAJE

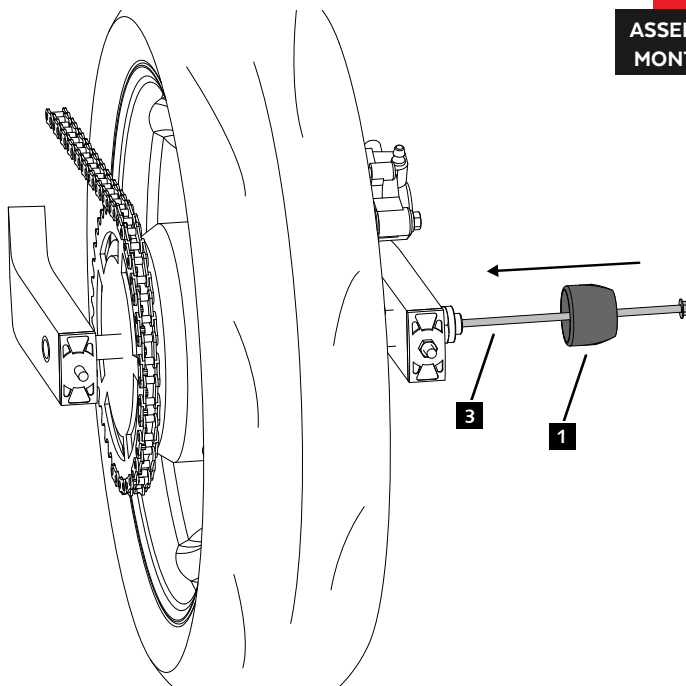
**2**

ASSEMBLY  
MONTAJE

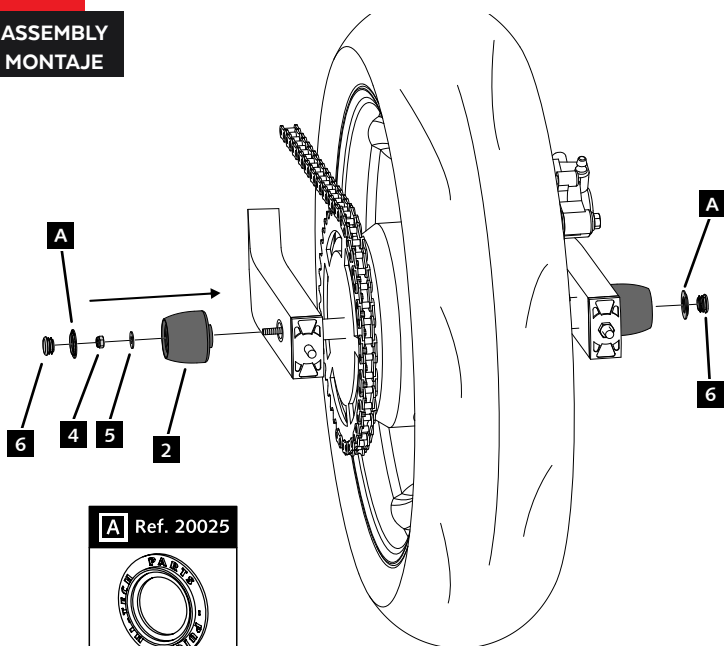
**3**

ASSEMBLY  
MONTAJE

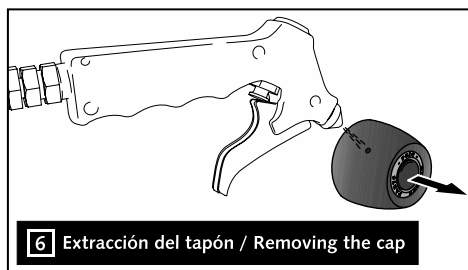
**6**

Extracción del tapón / Removing the cap
